# Manhole Inspection Summary

Manhole # S53Q\_\_011MH

Insp Date: **9/5/08 1:33 PM**

**Location** Address: **3201 boston st**

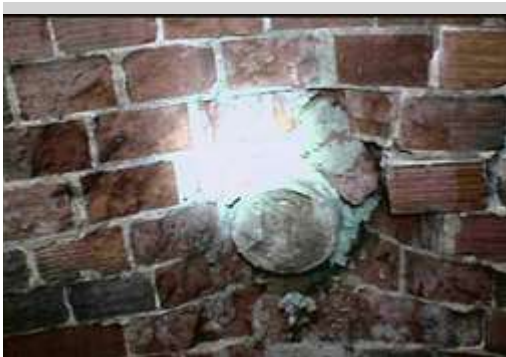
Defect 4

Condition: ☐ Sound ☒ **Cracked** ☐ Root Intrusion ☒ **Loose Brick** ☐ Deteriorated

cracked, loose bricks barrel

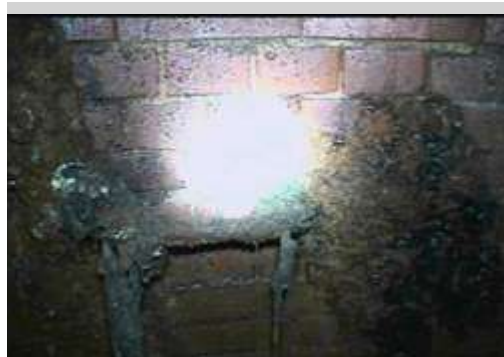
Defect 3

Infiltration: ☐ None ☐ Joint ☐ Cracks ☐ Mortar ☐ Roots ☒ **Wall**

infiltration in barrel( on the right side of the light)

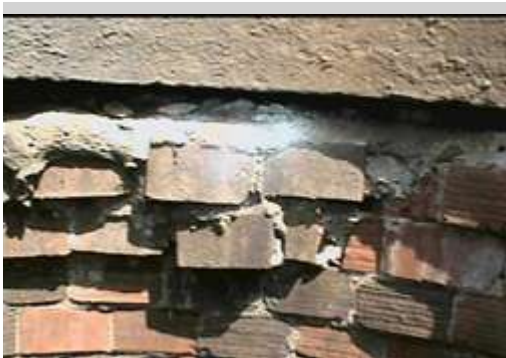
Defect 2

Condition: ☐ Sound ☐ Cracked ☐ Root Intrusion ☒ **Loose Brick** ☒ **Deteriorated**

chimney loose bricks, deteriorated frame adj

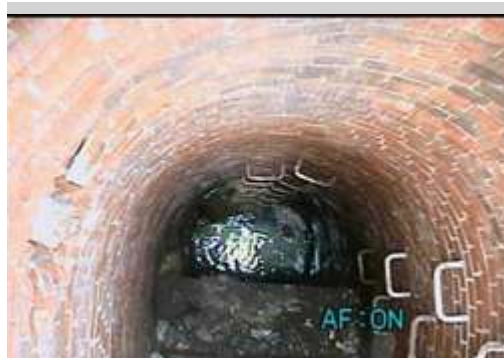
Defect 1

Count: **20** Missing: **0** ☒ **Corroded**

corroded &  
2 sets of steps
